500 kV Transmission line

CHOM BUNG (CBG) – SAI NOI (SNO) No. 1, 2 and 3

CHOM BUNG (CBG) – PHA CHI (PH2)

Trip, Recloser in “OFF” position

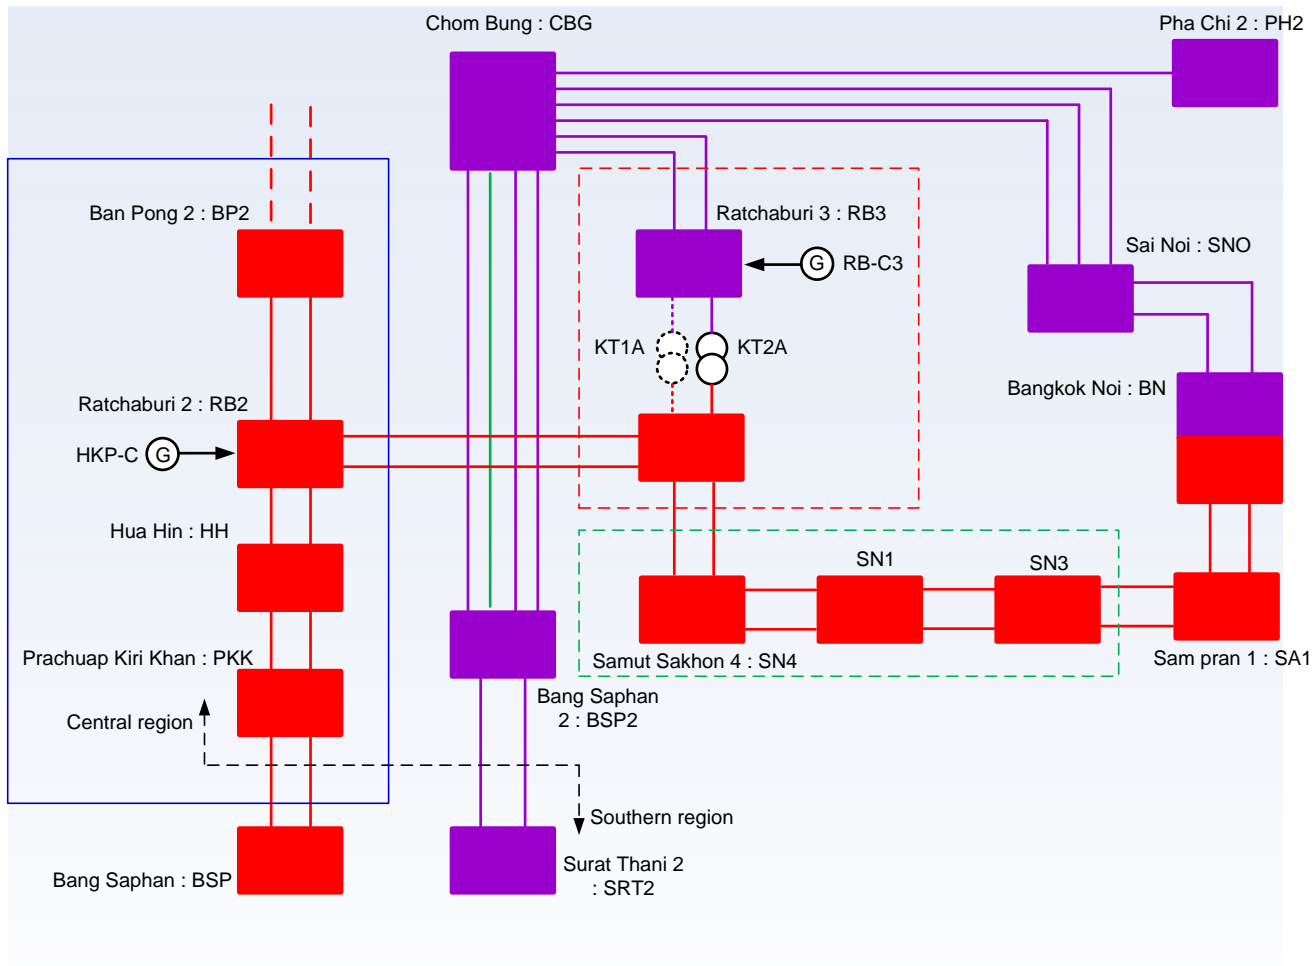
Introduction of transmission system tie-line

500 kV Chom Bung substation connected with transmission line 500 kV CBG – SNO for 3 circuits, 500 kV CBG – PH2 and 500 kV CBG – RB3 for 2 circuits which received power from transformer 500/230 kV KT2A.

Power transmission from central region to southern region of Thailand through transmission line 500 kV CBG – BSP2 for 4 circuits (No. 2 switch off for reduce voltage) and 230 kV BSP – PKK for 2 circuits.

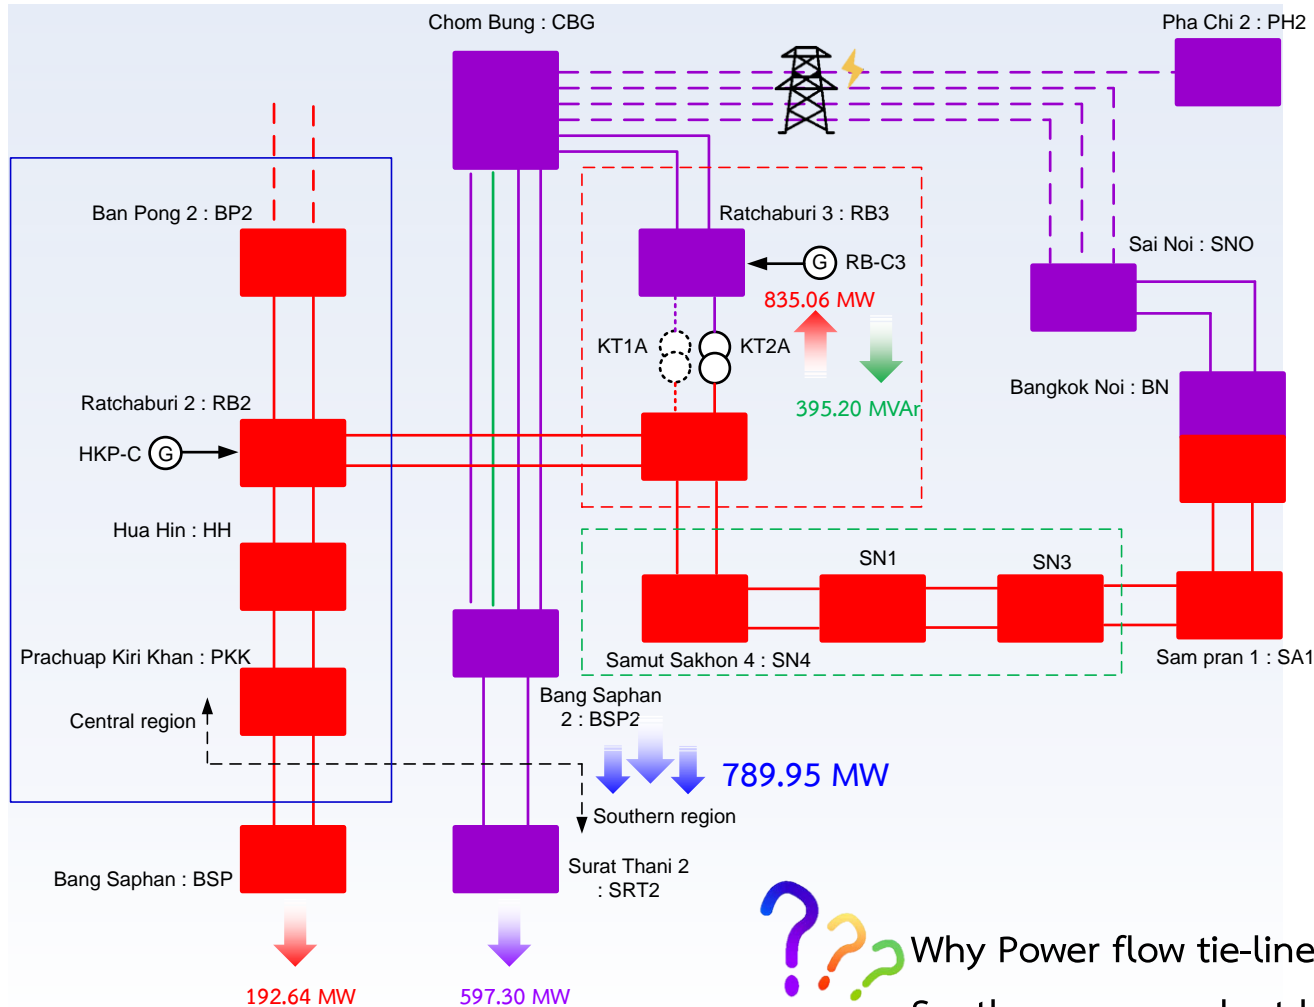
System condition after fault event

Transformer 500/230 kV RB3 KT2A overload with power flow 923.9 MVA (123.2 % overload).

Power flow tie - line (Central - Southern region) ~ 790.0 MW (Control not more than 750 MW without 500 kV transmission line)

In Worst case scenario transformer 500/230 kV RB3 KT2A Trip. As though not have 500 kV transmission line from CBG-Sub to STR2-Sub.

Why Power flow tie-line decreased significantly ?

Southern power plant both of Kanom and Chana combined cycle power plant increased power output.

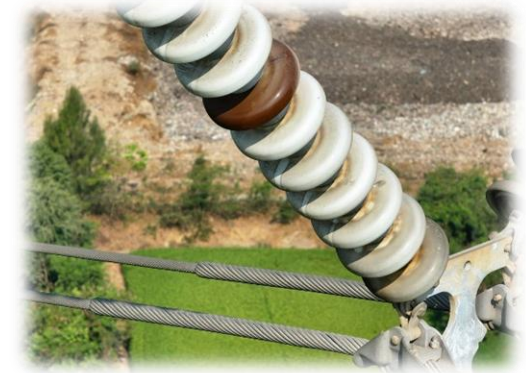
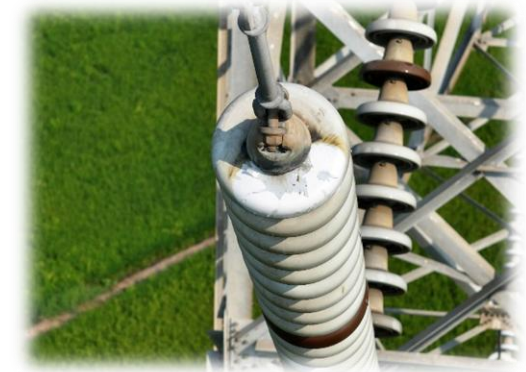
Cause : High pollution and relative humidity result to

- 500 kV CBG – SNO No. 2. Insulator flashover on phase C.
- 500 kV CBG – SNO No. 3. Insulator flashover on phase A.
- 500 kV CBG – PH2 Insulator flashover on phase A.

- 08:12, 08:18 a.m. Reconnected 500 kV CBG – SNO No. 1, 2
- 08:22 a.m. Chana combined cycle GT11 synchronized generator to grid.
- 11:14 a.m. Reconnected 500 kV CBG – PH2
- 12:01 a.m. Chana combined cycle ST10 synchronized generator to grid.
- 17:02 p.m. Reconnected 500 kV CBG – SNO No. 3
